PROJECT TIMPLEMENTATION

3. CONSERVATION OF THE TEMPLE OF ALLAT (Activity 3)

5. EMERGENCY INTERVENTIONS

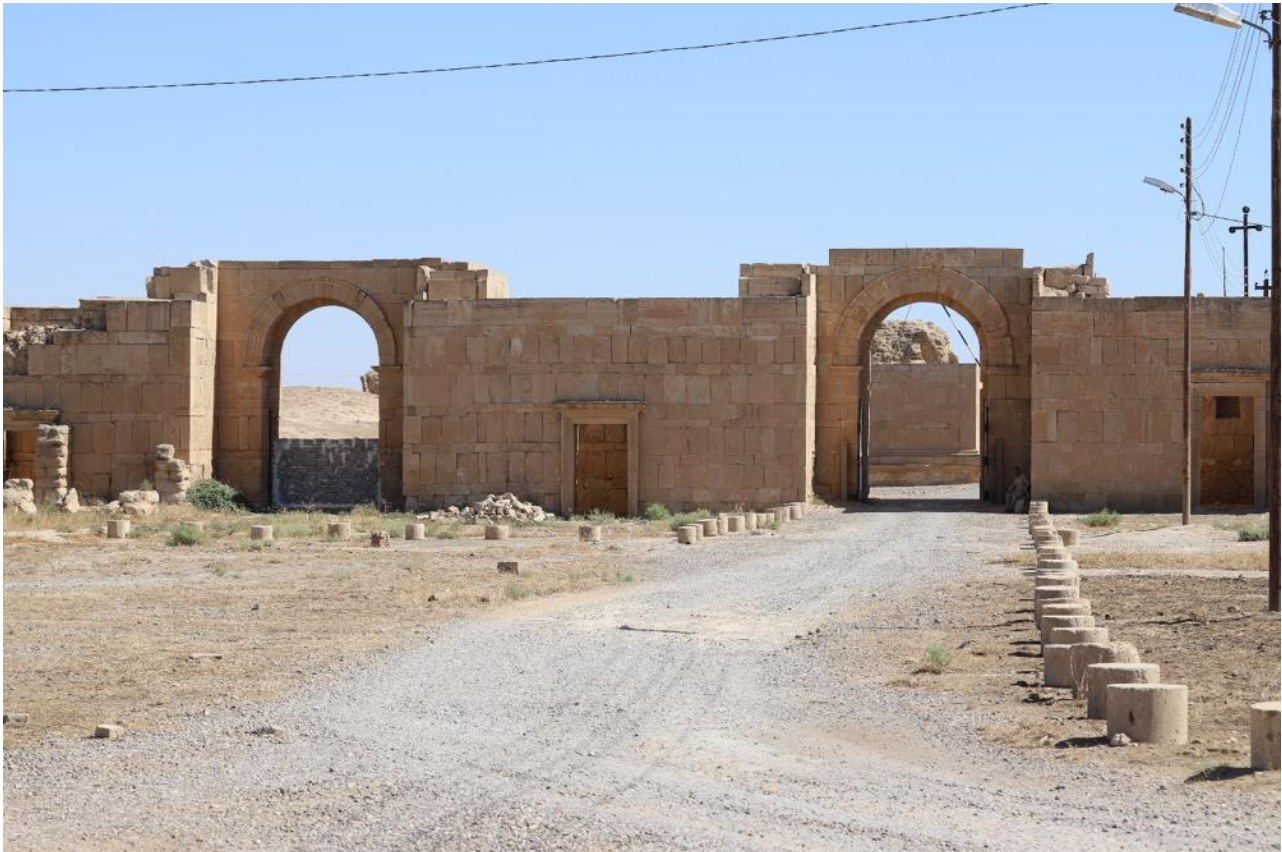
Fig. 1: Central Temenos, eastern wall of the enclosure with the two monumental entrances.

The security of the archaeological site was implemented with the closure of the second monumental entrance of the central *Temenos* (Figs- 1-2) and the placement of cabins for the use of the police forces (Figs. 00-00); a fixed masonry post overlooking the entire extension of the site (300 ha) was built on the roof of the Archaeological Police house.

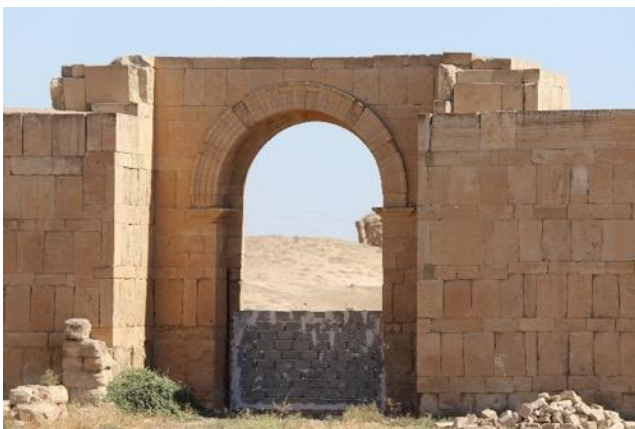
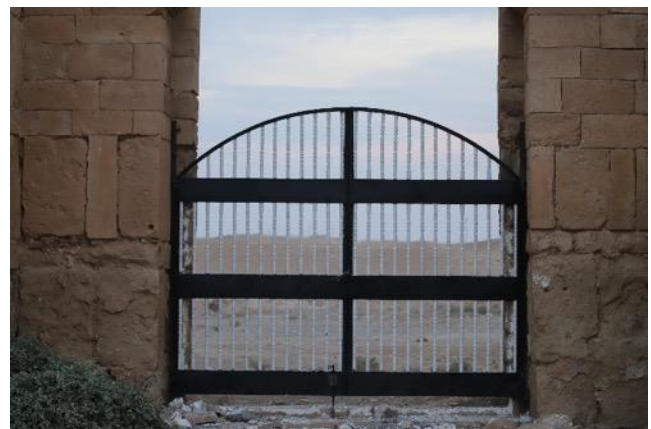
Figs. 2-3: Detail of the northern entrance partially walled and (3) after the assembly of the iron gate.

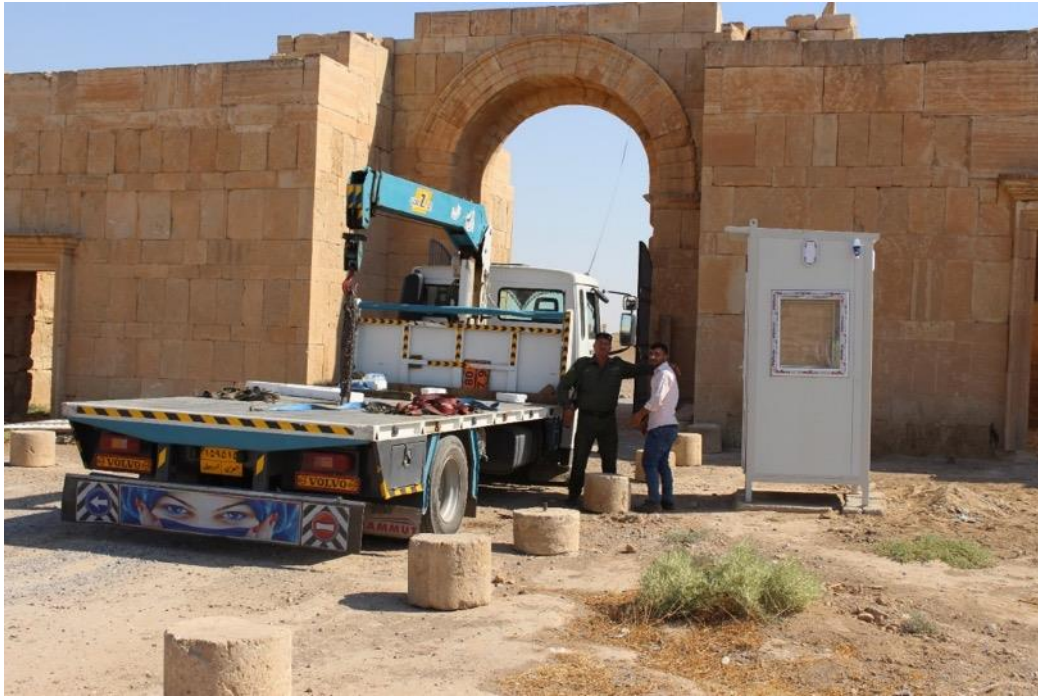
Fig. 4: Positioning a cabin for the police guards at the main entrance of the central Temenos.

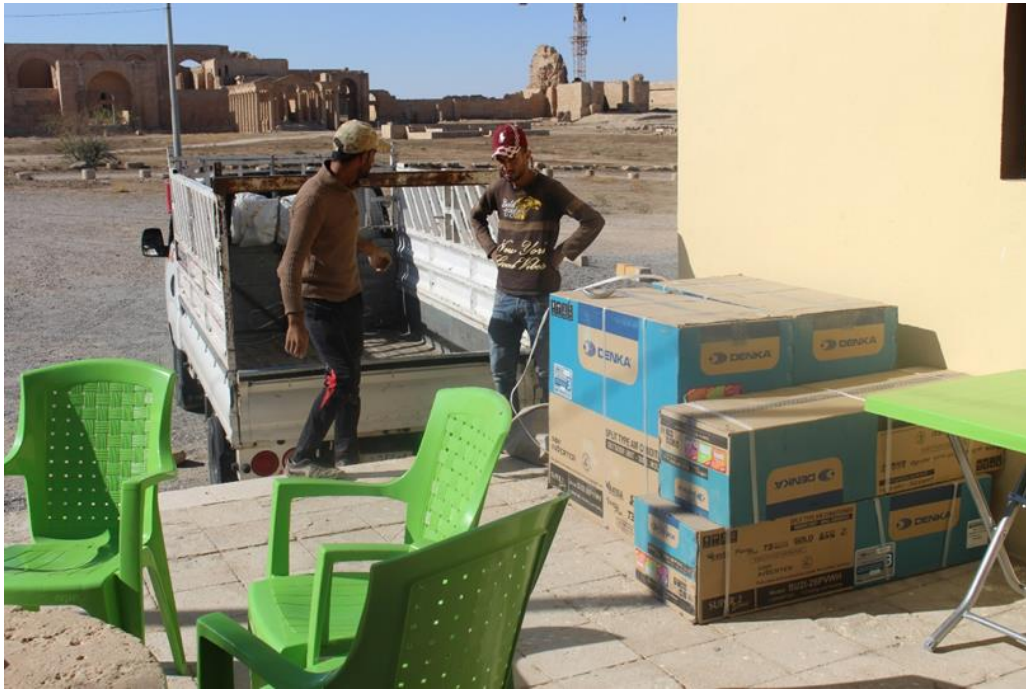
Fig. 12: Heating/air conditioning system.

- installation of a heating/air conditioning system in the main hall of the house, the most important common work and meeting place of the compound;
- installation of a console for instrumentation (always in the main hall);

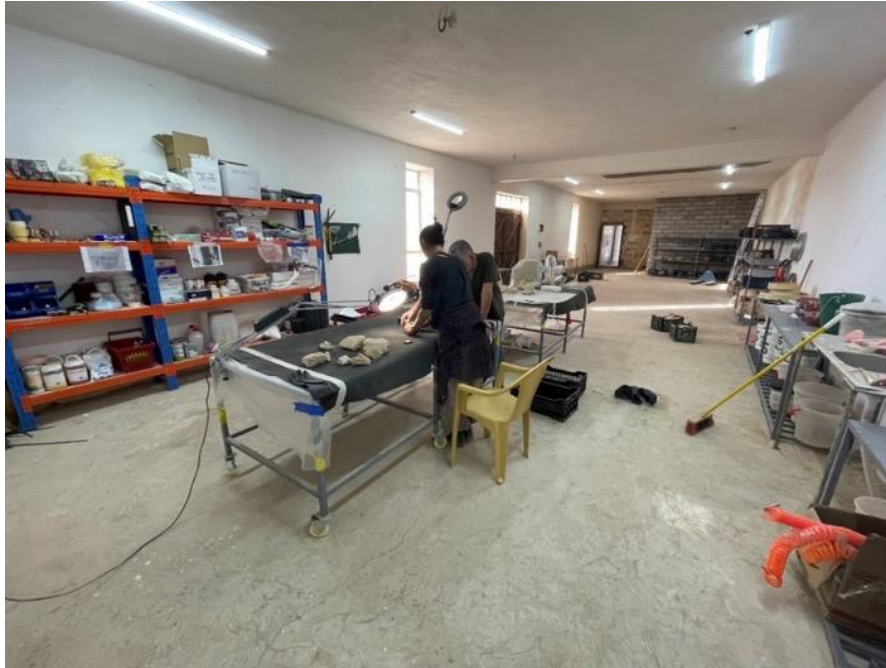
Fig. 14: The restoration lab with the new shelving.

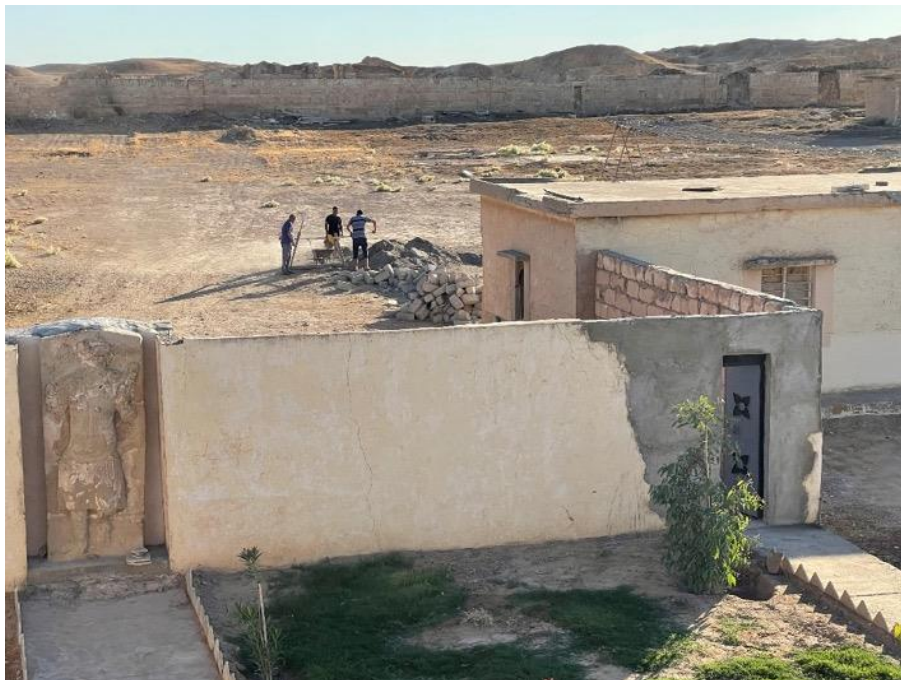
Fig. 15: Restoration of the garden fence wall and rebuilding of the access door to the Lab courtyard.

- restoration of the garden fence wall and rebuilding of the access door to the courtyard in front of the laboratory;
- restoration of a pre-existing but abandoned vegetables orchard in front of the restored Police Station, and its protection by the means of an iron wire fence;
- reactivation of the irrigation system, fed from the ancient tanks and wells of Hatra's sanctuary, for irrigation of the restored garden and the vegetable orchard (fig. 00-00)
- for the laboratory, building new shelves for equipment and storage of sculptural and architectural fragments from the area of the Great Iwans Complex and the Temple of the Triad.

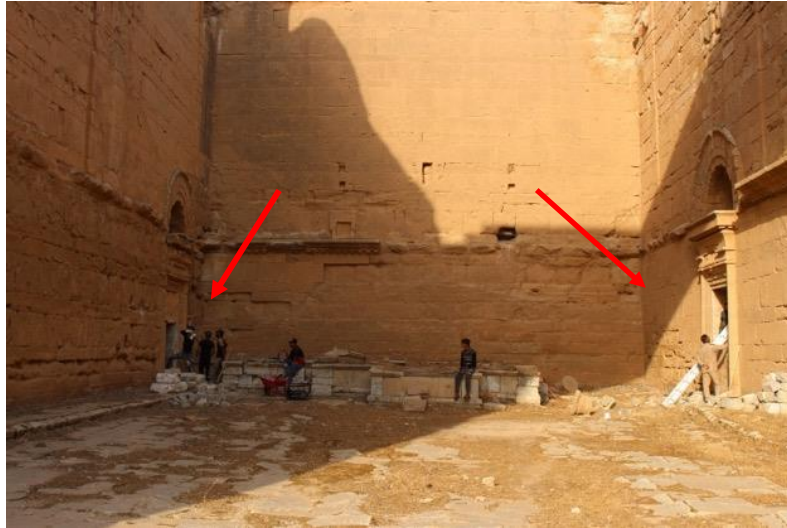
Fig. 23: Great Iwans Complex, North Iwan with the two entrances to halls 8 (on the left) and 10 (on the right).

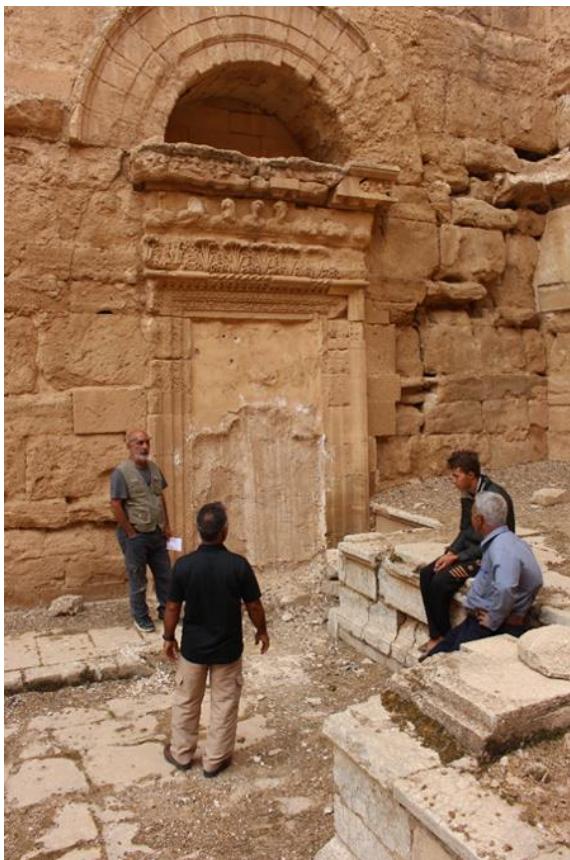
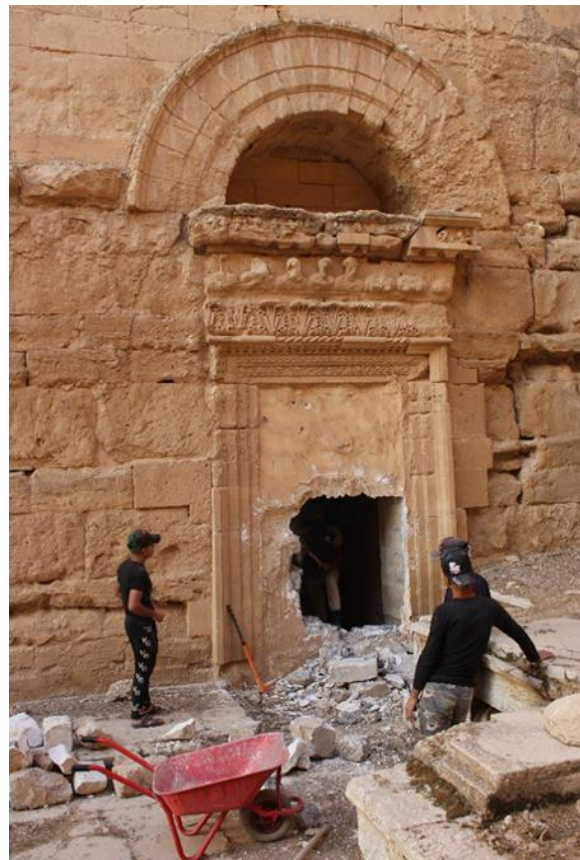
Figs. 24- 25: The opening of the entrance to room 8.

During the ISIS occupation, the walled rooms were broken in and the contents severely vandalized. The material was documented photographically, and the entrances closed with iron gates. The keys have been handed over to the Director of the archaeological site and the command of the Archaeological Police. In February the pieces will be catalogued and a recovery plan drawn up.

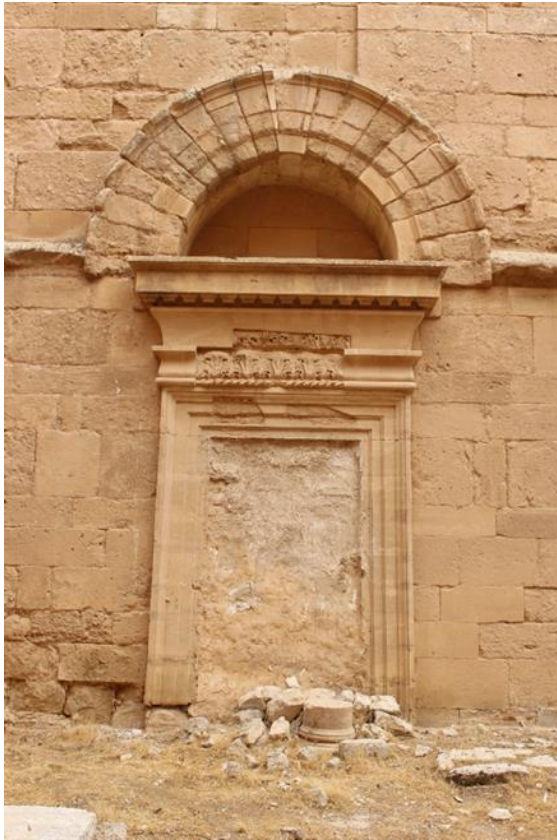
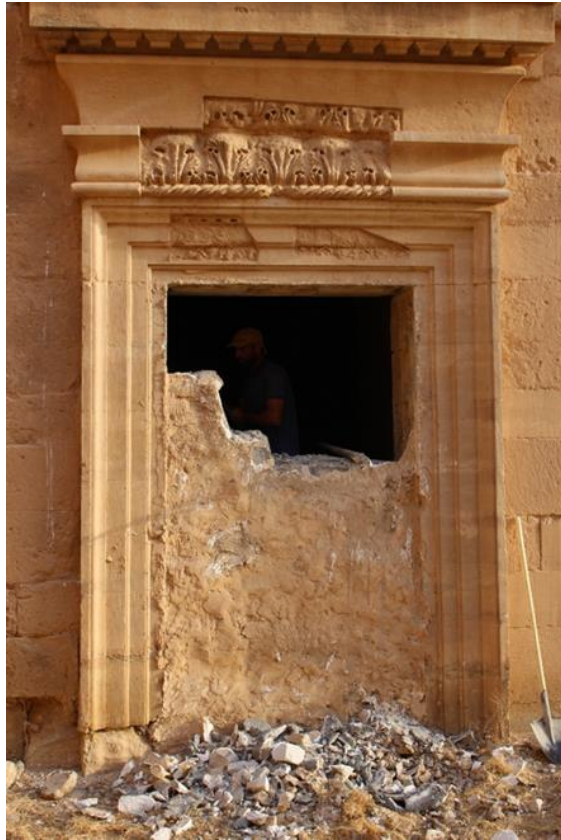
Figs. 30- 32: The opening of the entrance to room 10. Below the detail of the carved panel that decorates the architrave.

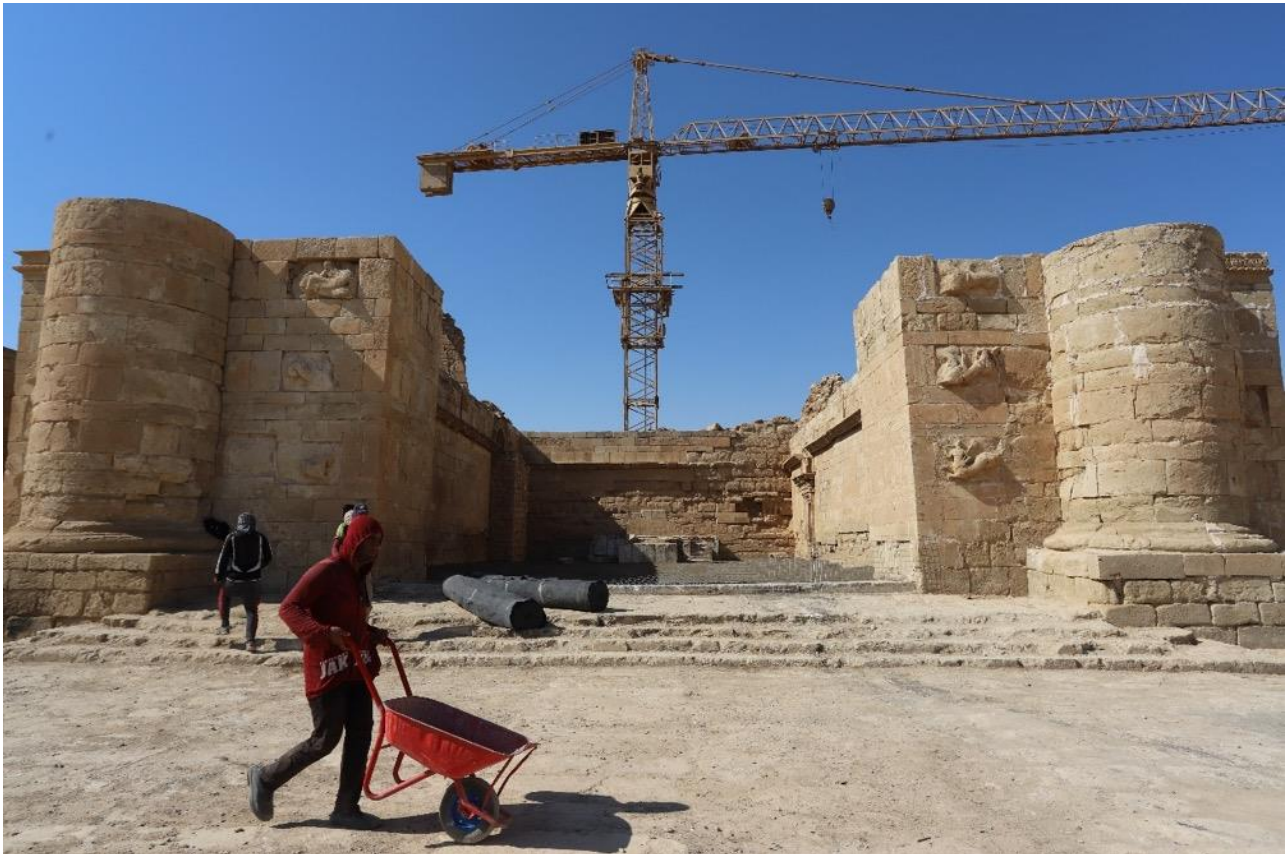
The Temple of Allat was the subject of further conservation activities during the last two weeks of October, under the supervision of M. Vidale. The floors of the three iwans of the Temple were finally cleaned of a few grass patches and isolated bushes that had regrown on the alabaster floors after the last cleaning operations. Next, all the cleaned alabaster/gypsum floors and parts of the floors where the alabaster slabs had been removed and only earth was left were covered with non-woven black fabrics, and in turn covered with a 20 cm layer of coarse black sand from the nearby river beds.

Fig. 40: Temple of Allat, view of the central iwan during intervention.

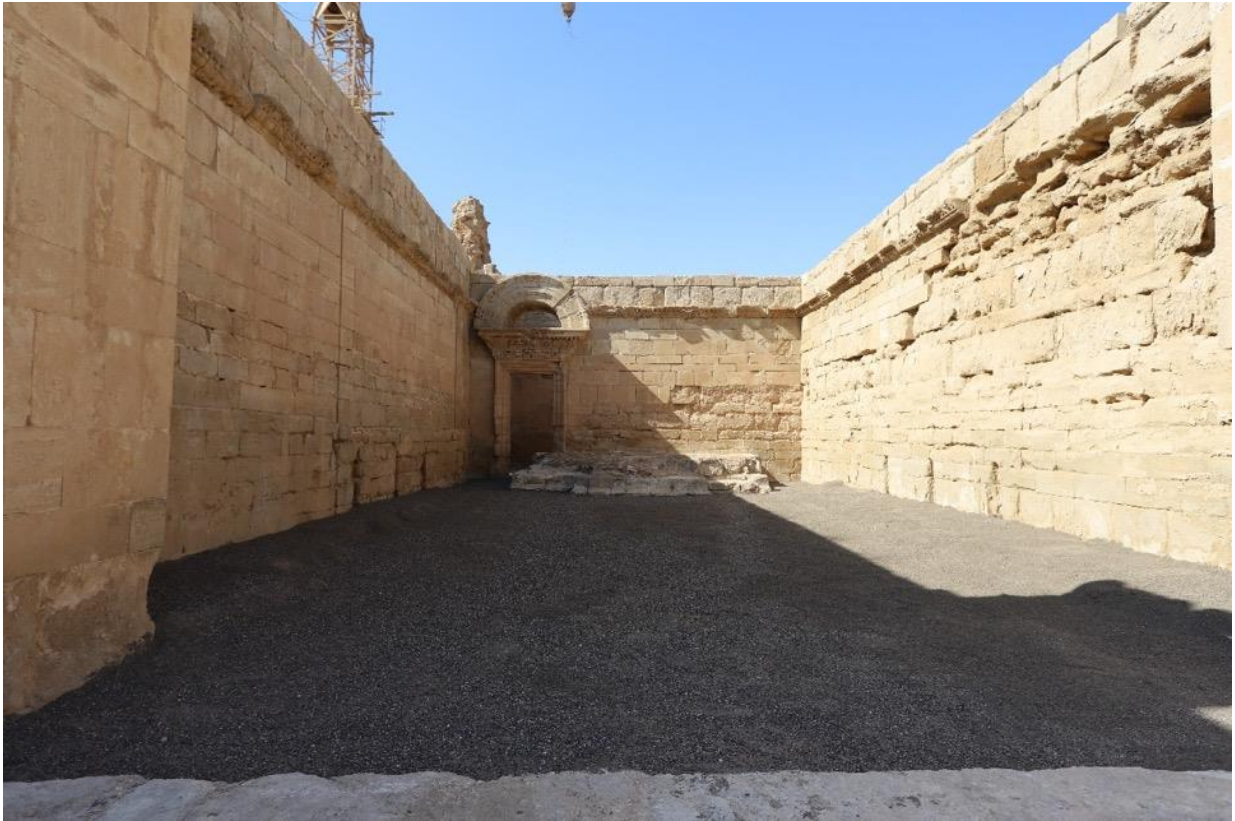
Figs. 41- 42: Temple of Allat, the central iwan after intervention.

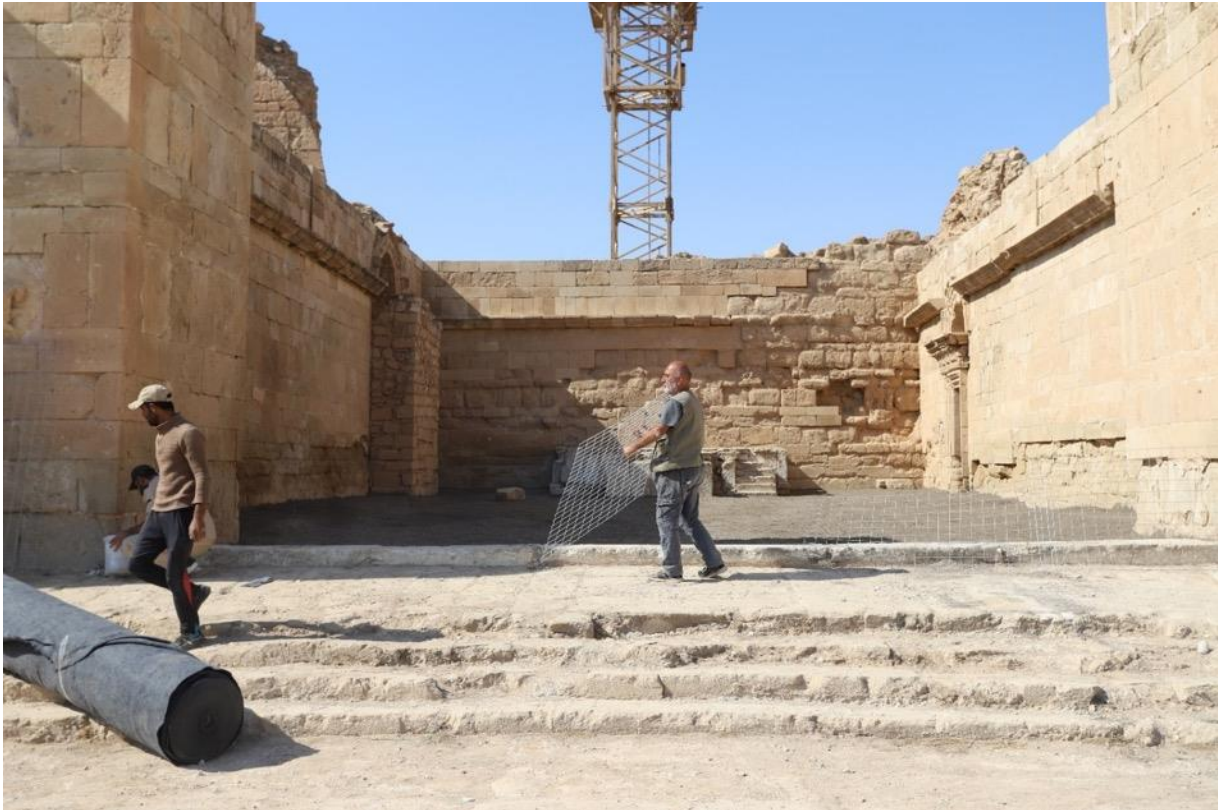
The entrances to the Temple's iwans were temporarily sealed with removable light iron frames and nets, not visible from distance, in order to prevent animals to enter and disturb such protective floors layers. The final effect of this provisional solution is aesthetically pleasant, but this is not certainly a final solution. In the next visits to the Temple, we should be able to record how far such provisional protection does relent the growth of vegetal organisms, and how fast and how deep it will deteriorate.

Fig. 43: Temple of Allat, central iwan with the entrance sealed with removable light iron frames and nets.

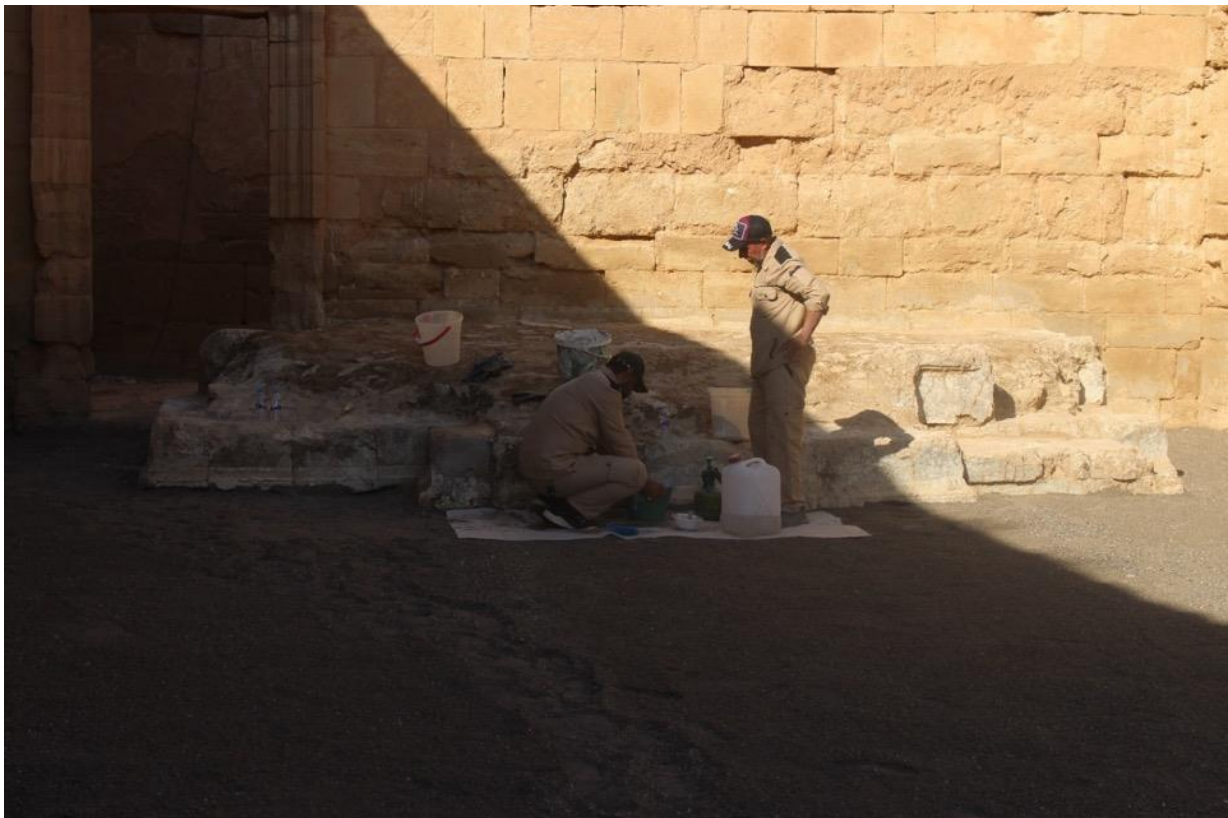
In the same contingency, on the damaged and eroded surfaces of two altars of Allat's iwans we prepared a set of a dozen protective patches of mortar (with two different recipes: cement-sand-lime and cement-sand fine clay) in order to test their relative strength, resistance to seasonal weathering and chromatic variations - for the moment - in the winter months (October to February).

Fig. 44: Temple of Allat, altar of the central iwan. Students preparing protective patches of mortar.

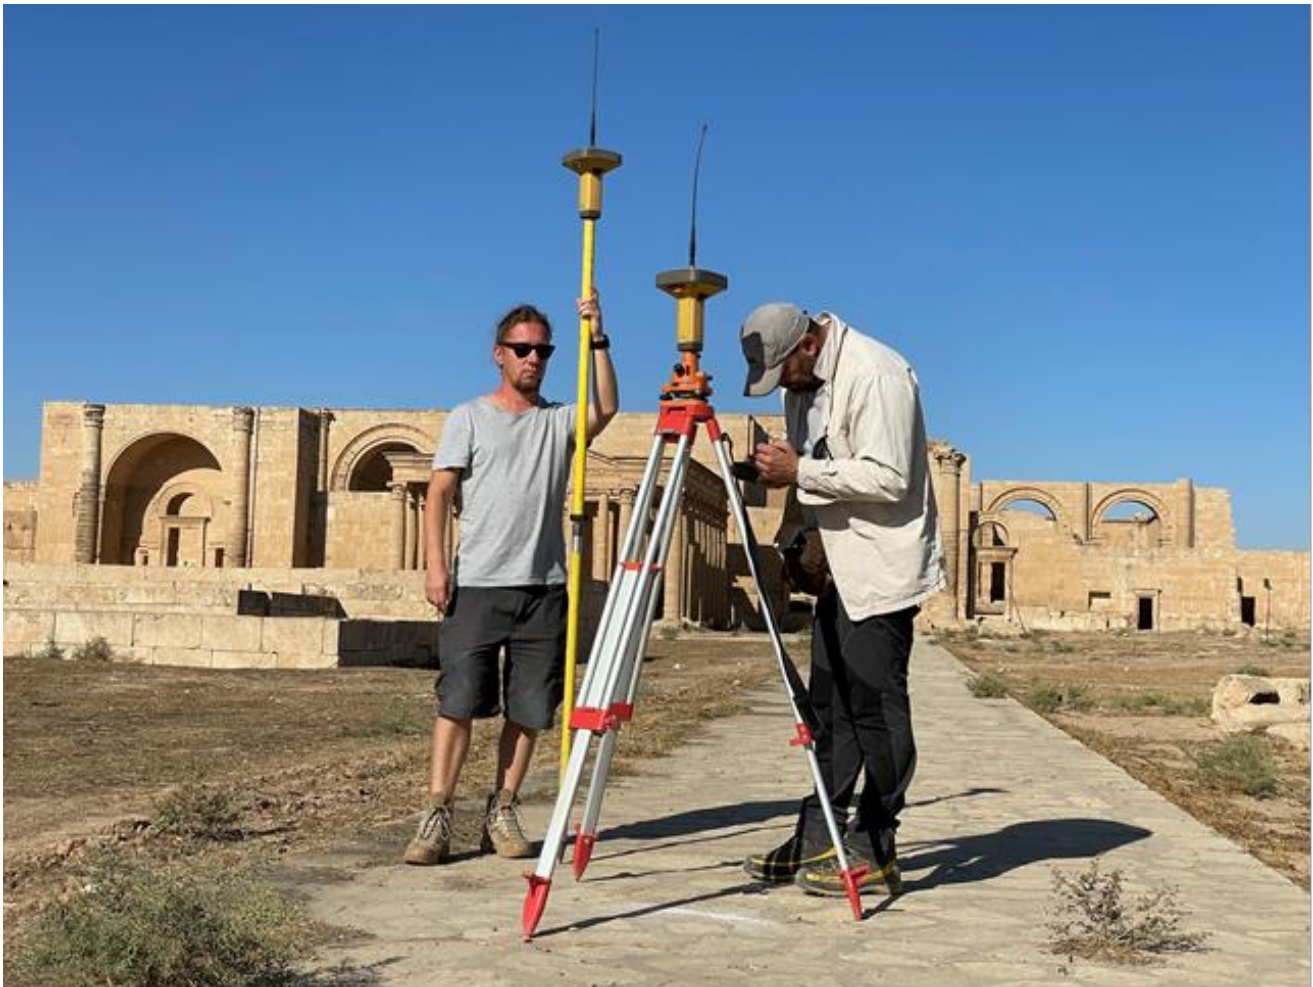
The first step of the field survey was aimed to build a topographic network based on geographic coordinates. As first instance we designed a topographical framework of the site by placing and processing topographic landmarks. The network was aimed to be used as reference for all - present and future - topographic survey activities within the site. After the placement of the landmarks in the ground (by drilling stones and screwing a screw into the stone), measurements have been carried out by GNSS. The survey has been implemented by setting RTK GNSS base and rover. The coordinates of the base station have been calculated by static 24 hours measurement of the vertex. The base acts like a remote base station which you can setup to receive RTCM correction data from. The other landmarks have been measured by the rover connected via UHF radio to the base station. All the reference points have been collected in WGS84 and turned in to the projected reference system UTM38N (EPSG:32638). For each vertex has been created a precise documentation with coordinates and location.

Fig. 45: Setting and measurement session of the GNSS base station and rover system.

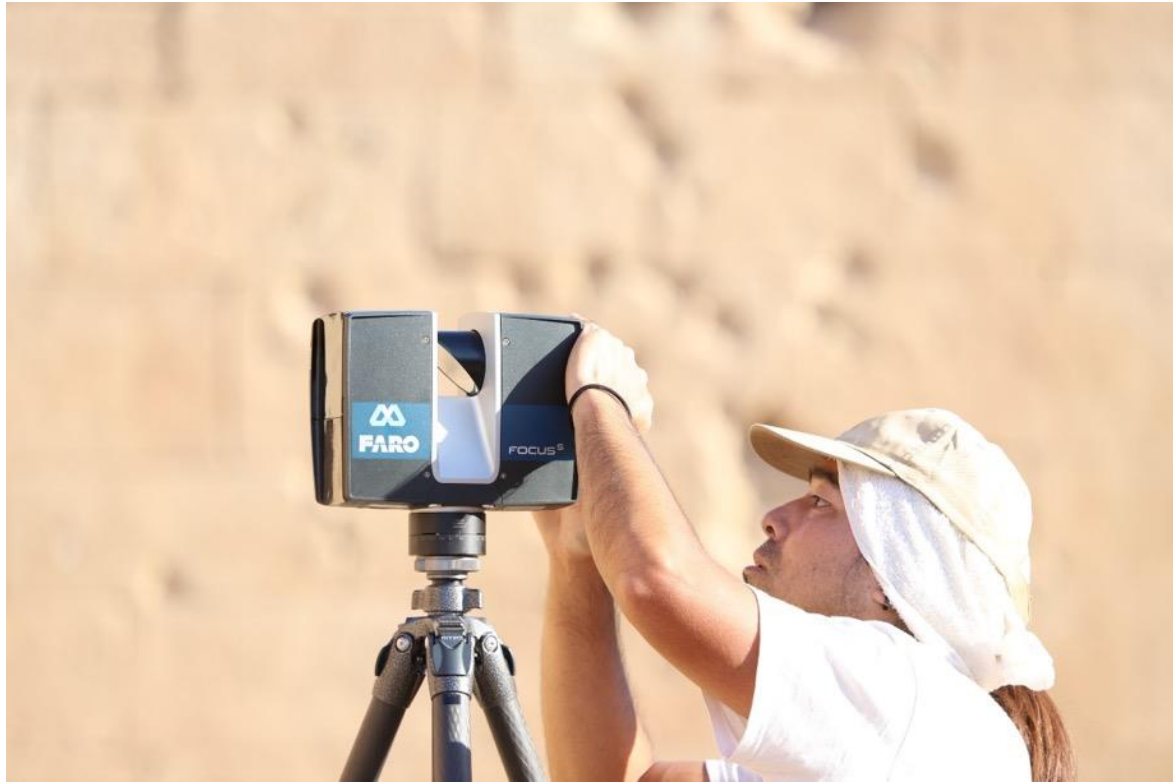
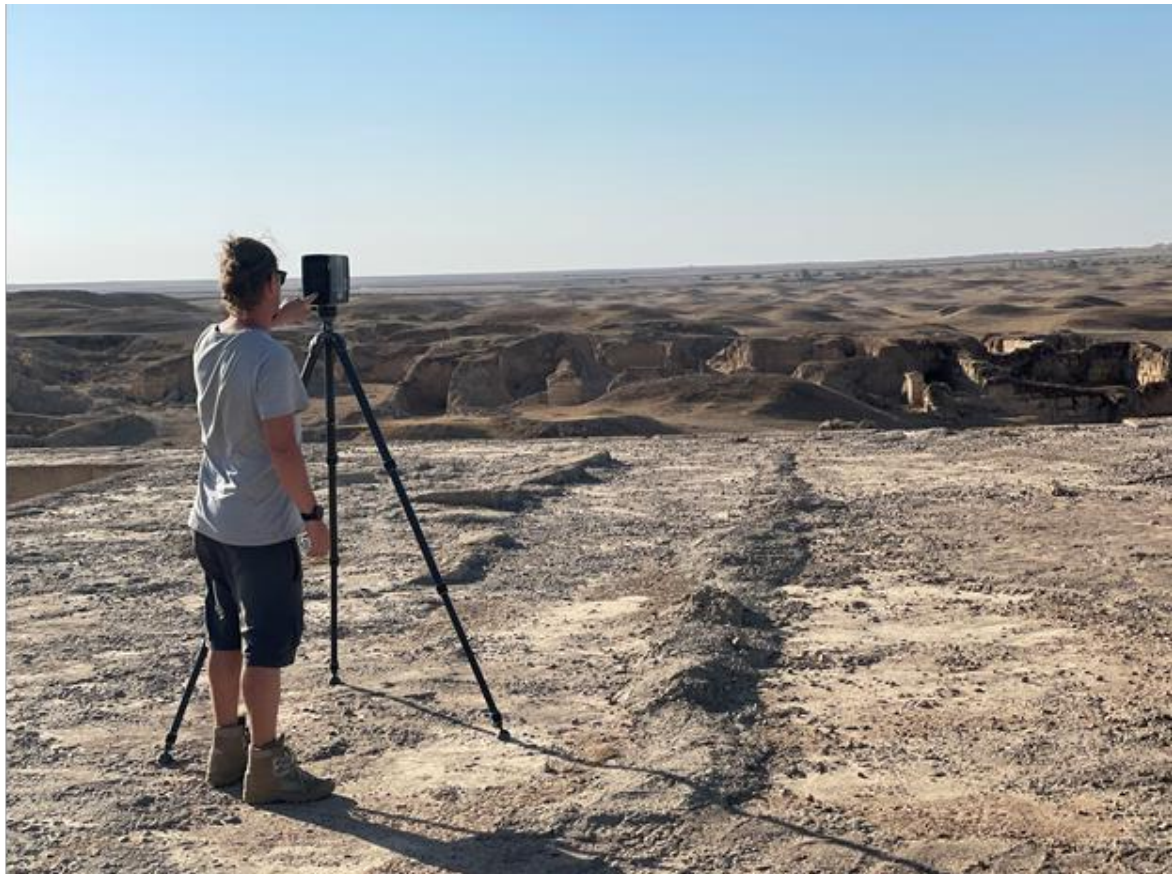
Fig. 48- 49: Laser scanning activity from the roof of the Great Iwans Complex.

Laser scanning survey has been carried out by Faro Focus Laser Scanner (Image 1). This device is able to scan objects from short range up to wide range (to a maximum of 350 m) with High Dynamic Range (HDR) photo overlay. Data acquisition by laser scanner at Hatra was proceeded in October 2021. Data acquisition was implemented in 11 days (06/10 – 16/10). Within 11 working days we collected 843 scan stations entirely covering the area of the temenos of Hatra, including both exterior and interior of any building and the defensive walls. The planning of the scans has been scheduled in order to minimize the number of occlusions present in the resulting point cloud and guarantee required resolution and comprehensiveness.

Furthermore, the digital camera integrated within the laser scanner allowed the acquisition of the texture, any pixel is associated with the related x, y, z point feature, obtaining a colored point cloud. The resulting point clouds have been processed by Leica Cyclone software in order to clean the point cloud from useless features and to register all scans in a single-global point cloud.

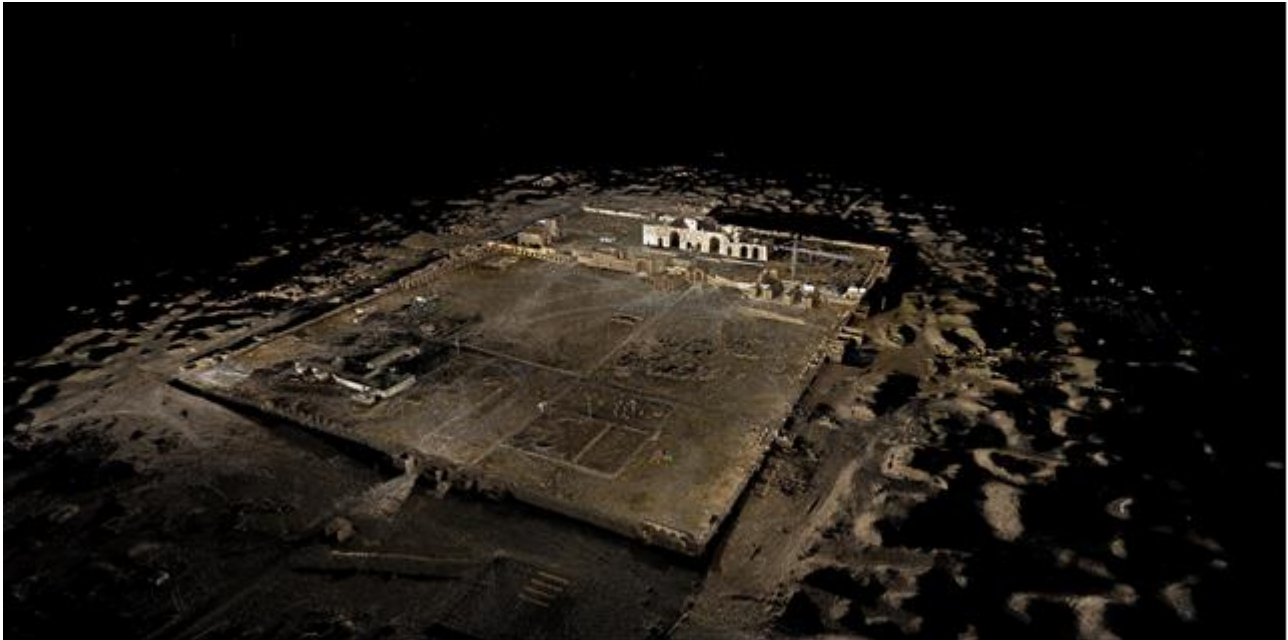
Fig. 50: Point cloud of the whole scanned area of the central Temenos.

The data processing is focused to produce a 3D textured model of the Temenos. Furthermore, the 3D point cloud is used to draw a 2D map and sections of the monument, to highlight the actual state and the degradation/structural problems.

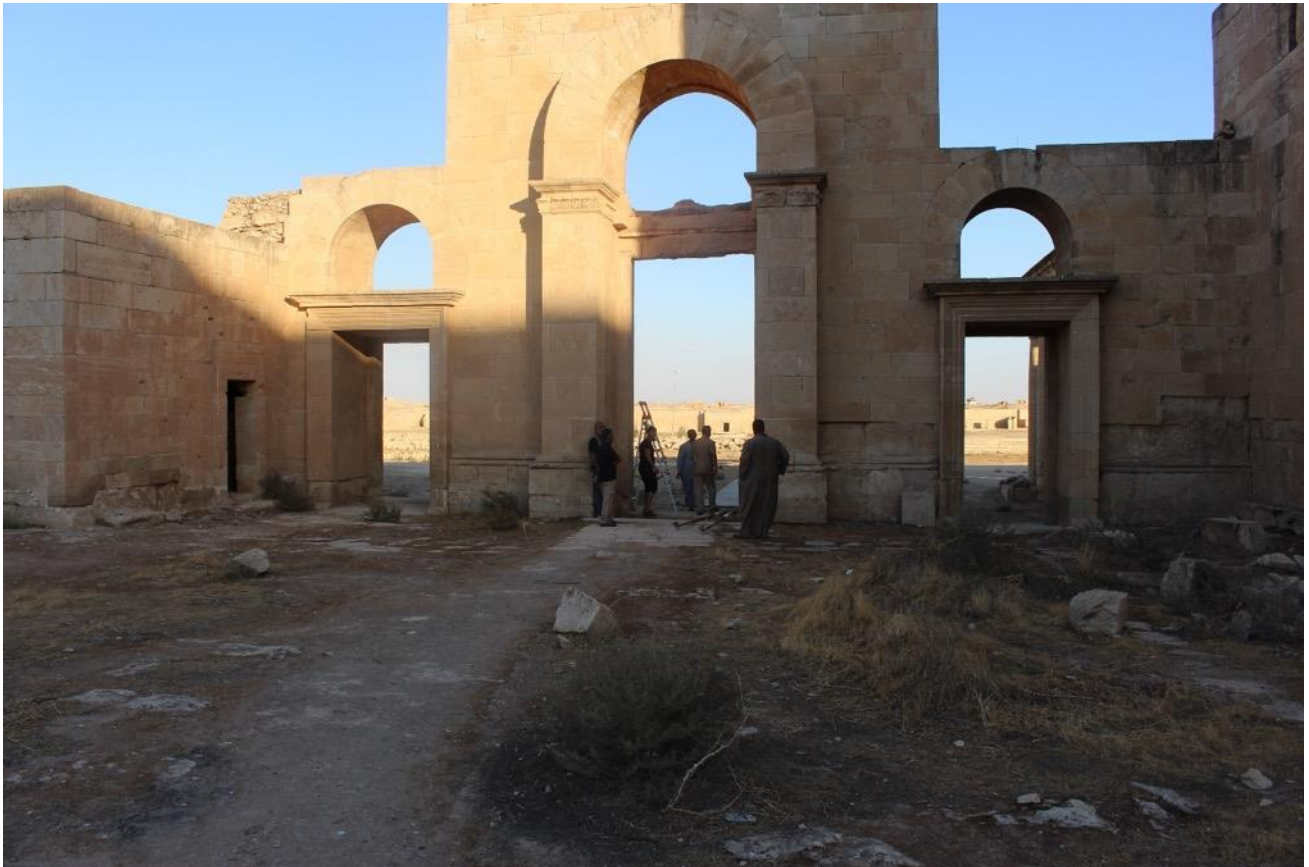
We had already emphasized, in the previous report, how the original architrave, placed above the modern lintels was almost completely eroded, and the sculpted features erased, and threatened by a passing-through lesion. As already state, in the immediate future it should be removed and substituted with a new stone replica. The entire vault, on the other hand, is damaged by rain seepage and processes of saline efflorescence. For sake of security, and waiting for future decisions, we temporarily supported the damaged architecture with a horizontal wooden plank supported with two vertical scaffolding pipes.

Fig. 51: Propylaea (western façade) during the inspection.

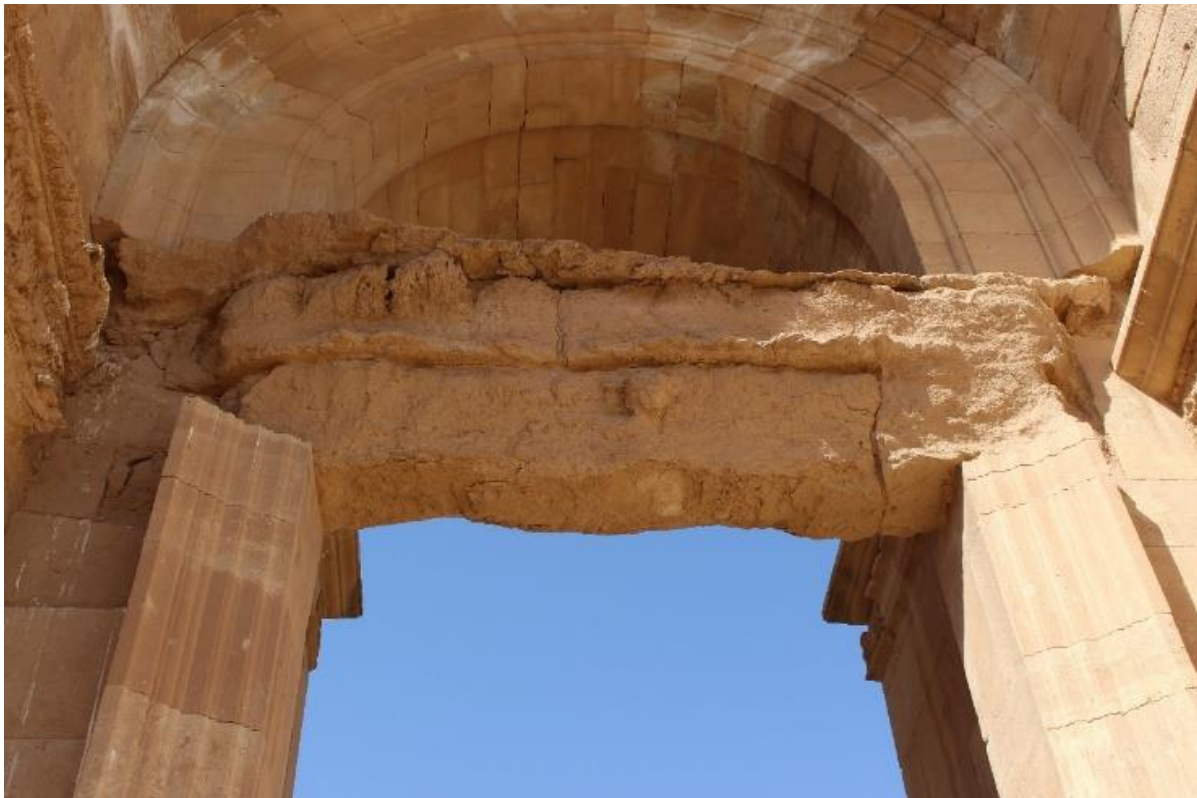
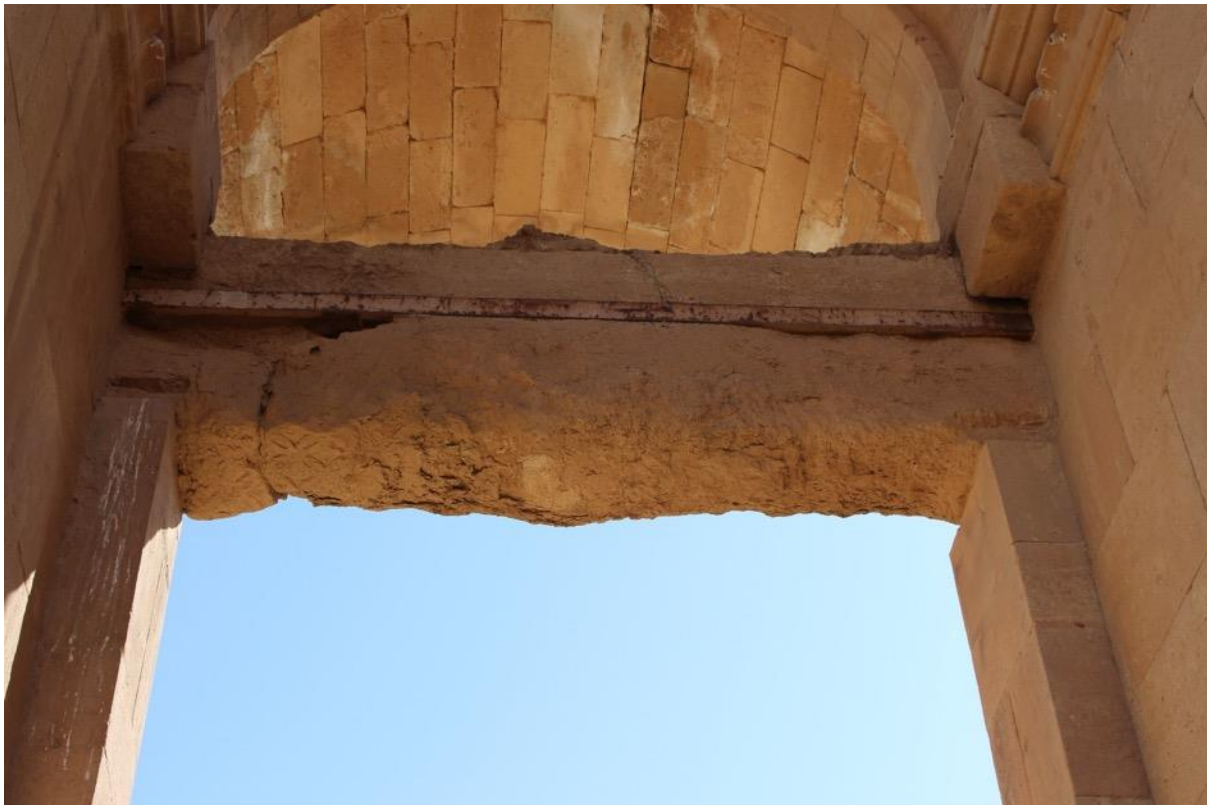
Fig. 52- 53: Eastern and (below) western façades of the lintel.

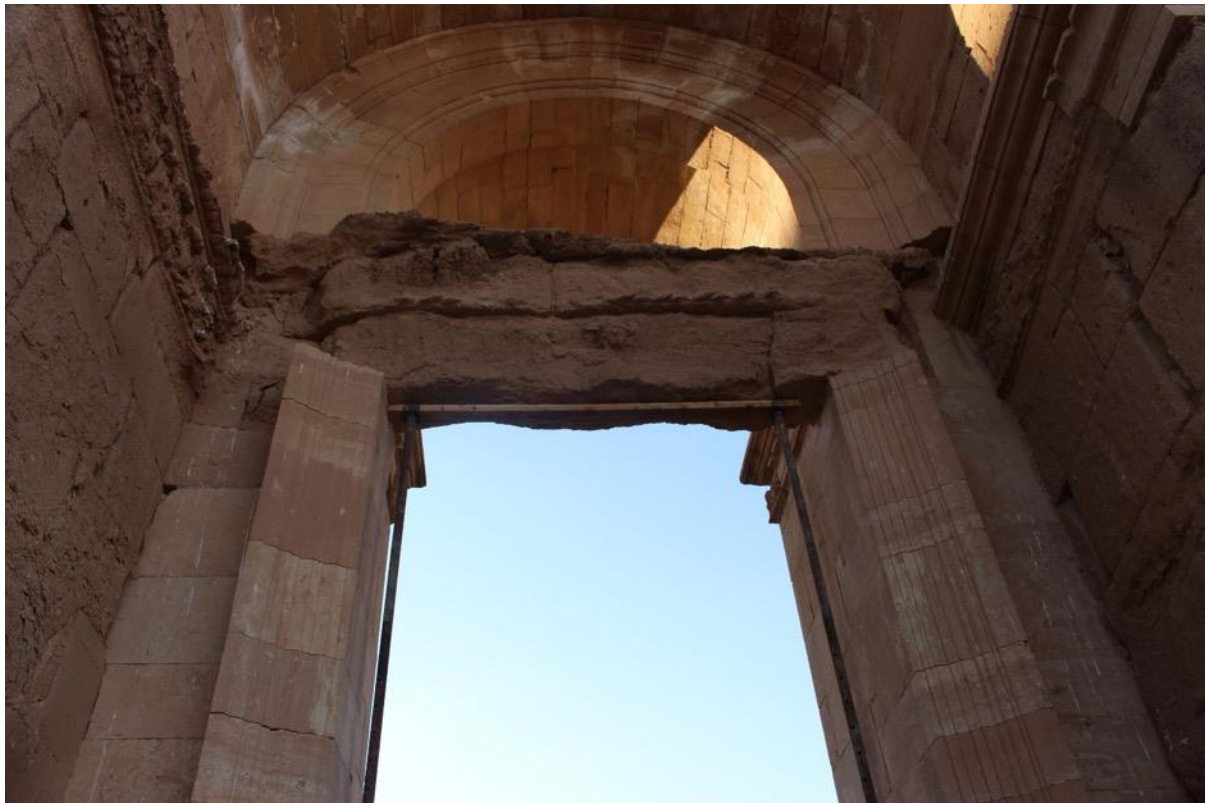
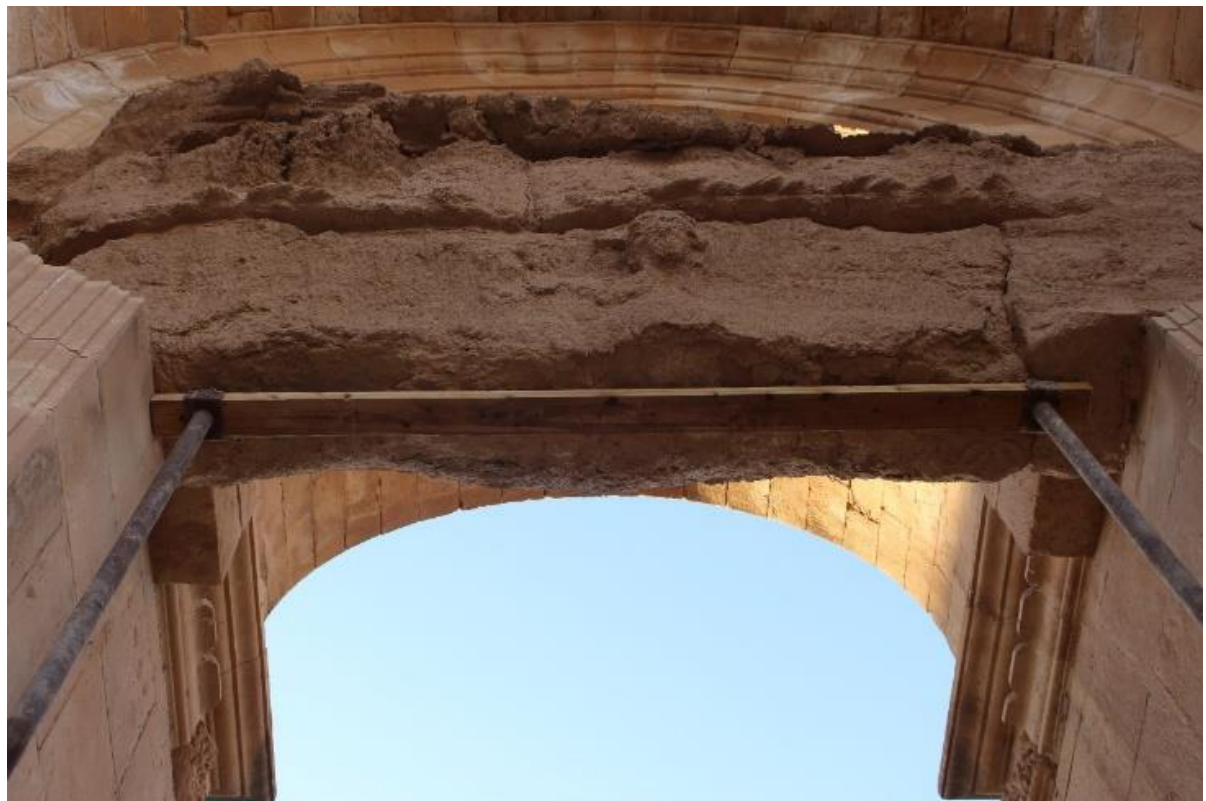
Figs 54- 55: Propylaea, main door after the emergency intervention.
