PROJECT TIMPLEMENTATION

3. CONSERVATION OF THE TEMPLE OF ALLAT (Activity 3)

5. EMERGENCY INTERVENTIONS

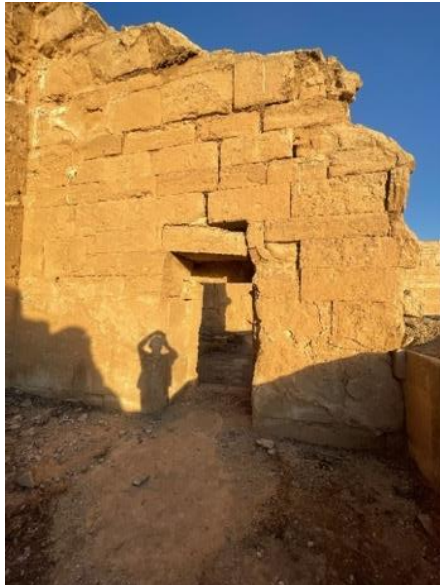
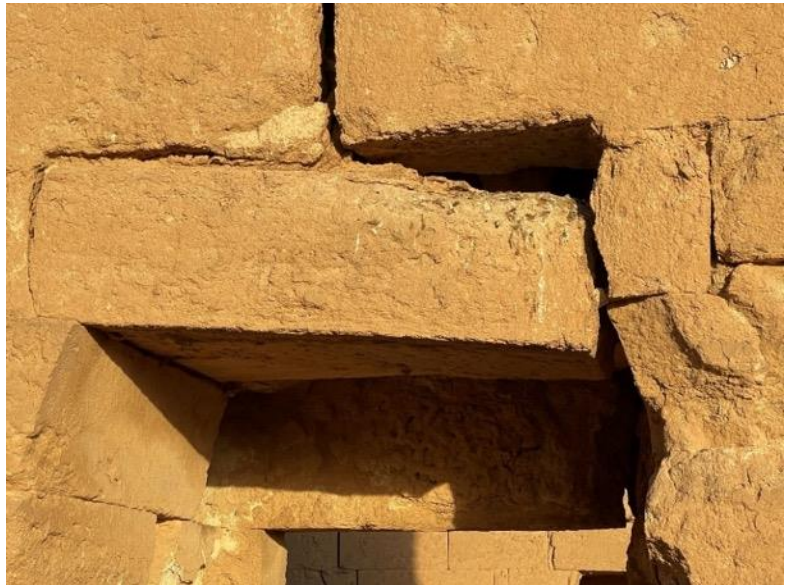
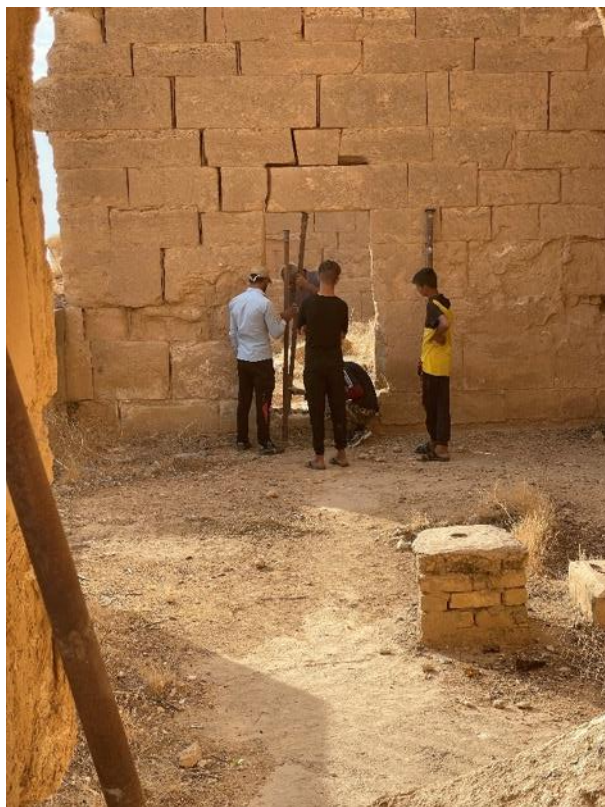
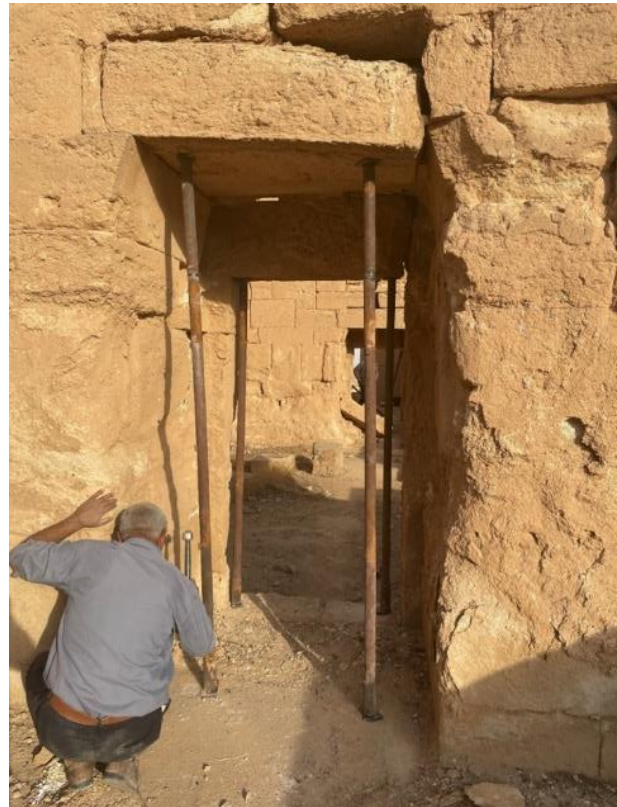
More crumbling lintels can be seen in the doors of some rooms on the second floor of the reconstructed Great Iwans complex. In these cases, as in the access to the Propylaea (see above) the doors have been temporarily fixed by supporting the lintels themselves with scaffolding pipes. Moreover, the accesses to the staircases leading to the second floors of the monumental buildings will be closed because they are dangerous for the visitors who venture to admire the landscape surrounding the archaeological site.

Figs. 56- 59: Crumbling lintel before and after the emergency intervention.

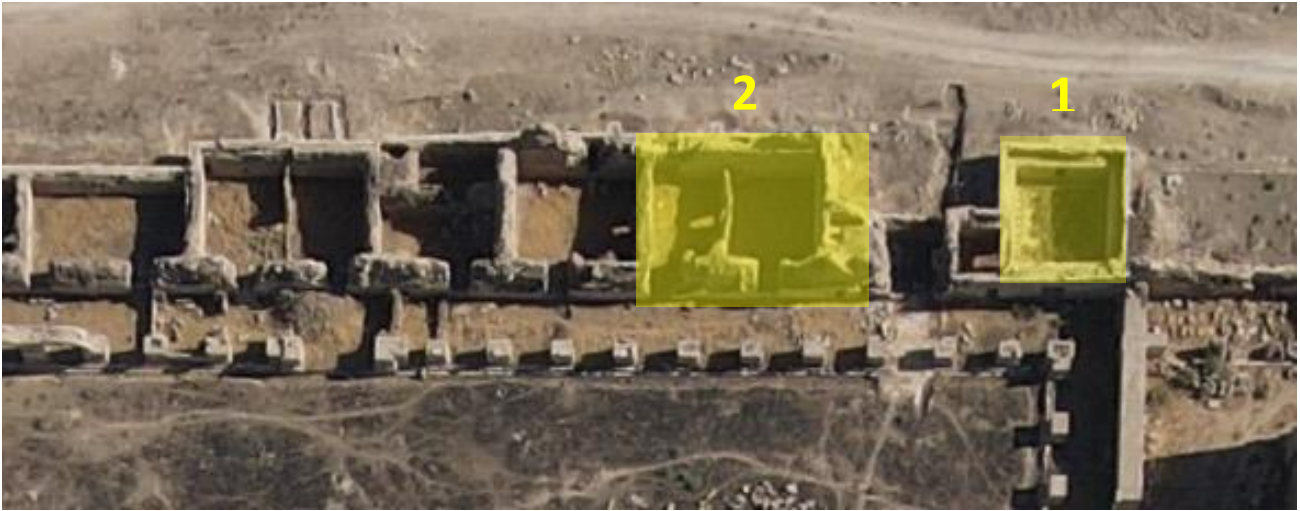
Fig. 60: Central Temenos, detail of the southern side of the enclosure wall, with the areas of intervention: 1. the room with hemispherical cups; 2. A large room with probable destination of worship, exceptionally accessible from the outside of the enclosure from the road that skirted it to the south.

In the south-western corner of the main court of the Hatra's urban sanctuary, connected with the porch, in the past was excavated an exceptional square room (the number 1 in fig. 60) whose floor, entirely covered with alabaster rectangular slabs, was surrounded all along the walls by parallelepiped-like blocks made of the same material, on which three continuous rows of hemispherical cups (40 in total) had been excavated. From the bottom of each cup, a lower channel discharged directly onto the room's floor, through an outlet placed in the middle of the face of each block. The function of this special room remains an enigma. After excavation, the room was abandoned in the open, thus gathering aeolian sediments and rain; eventually, abundant grass and bushes grew in the interstices among slabs and blocks, as well as within the cups themselves, with serious consequences for the integrity of this exquisite architecture. The room was entirely cleaned and recorded, waiting for a final decision on the way of protecting and safeguarding its integrity.

Other accesses and walls threatened by imminent collapses in the adjacent room (number 2 in fig. 60) were temporarily secured using scaffolding iron pipes and wooden planks.

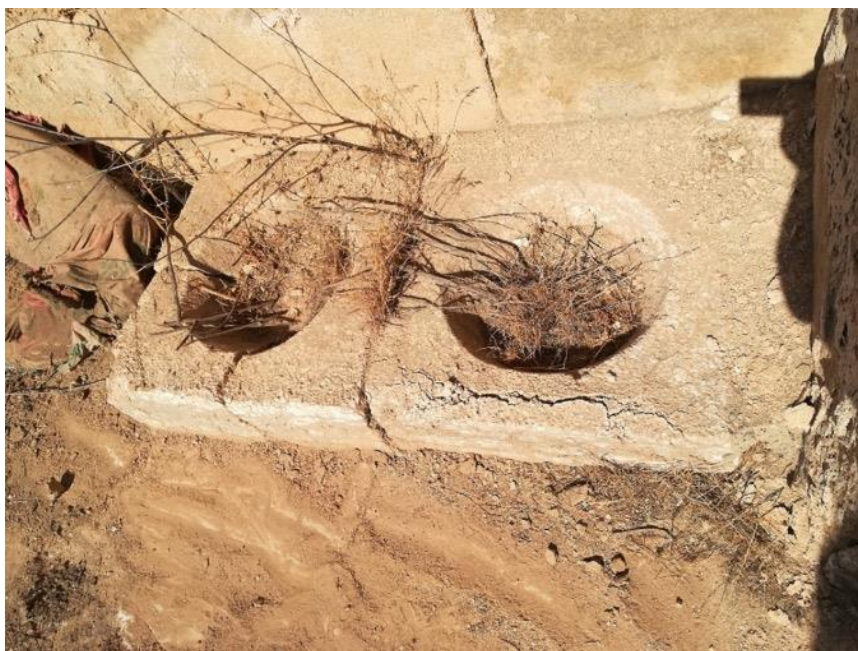
Fig. 61: Detail of two hemispherical cups with grass and bushes sinking roots directly into the decayed gypsum features.

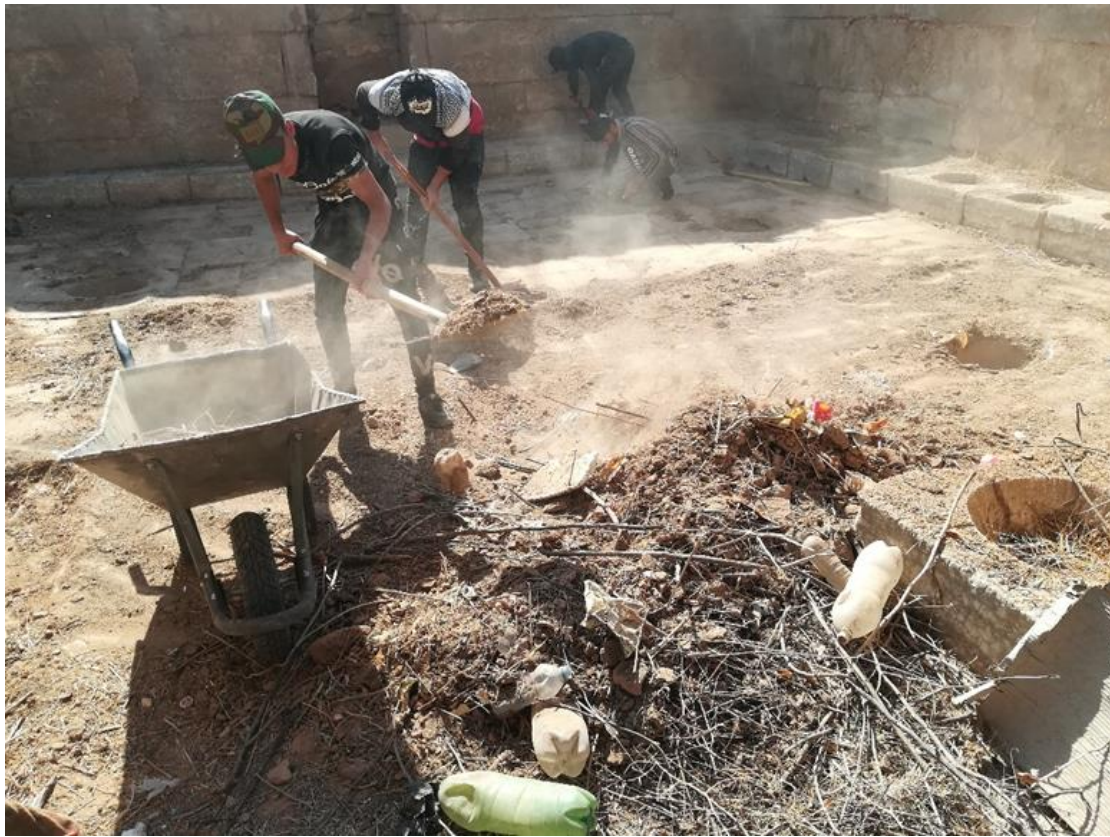
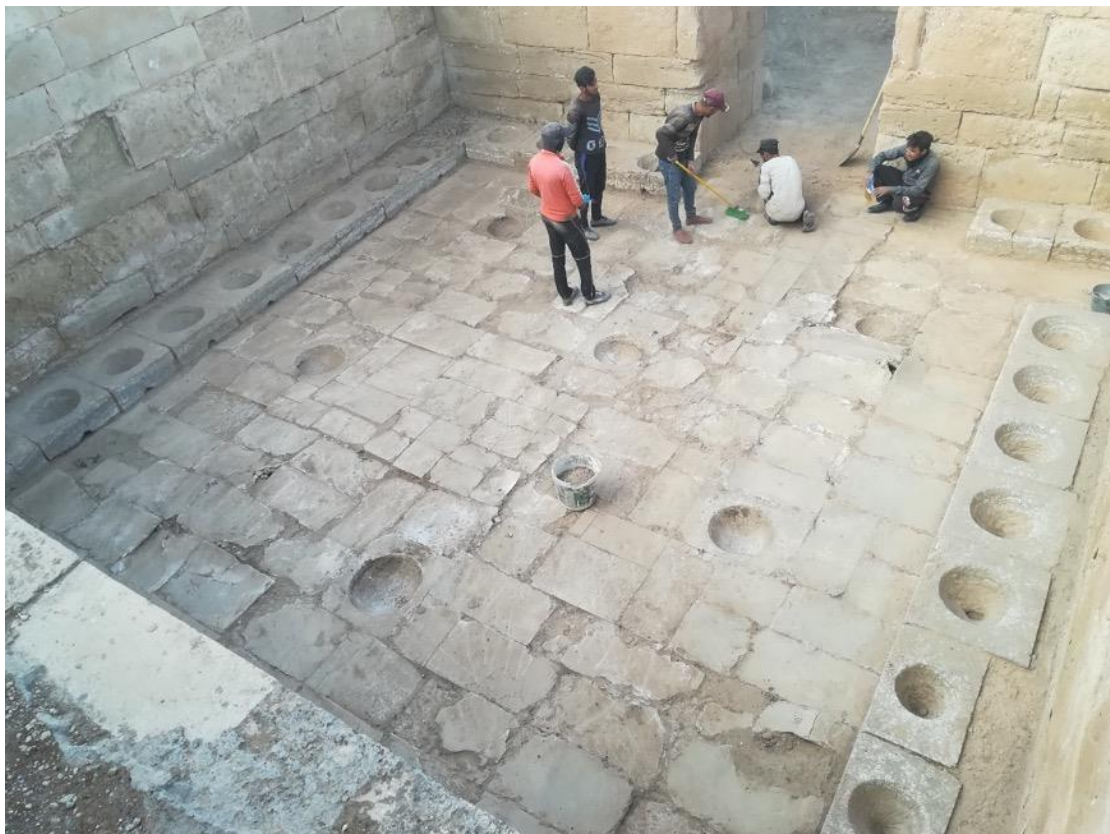
Figs. 62- 63: The room during and after excavation/ cleaning.

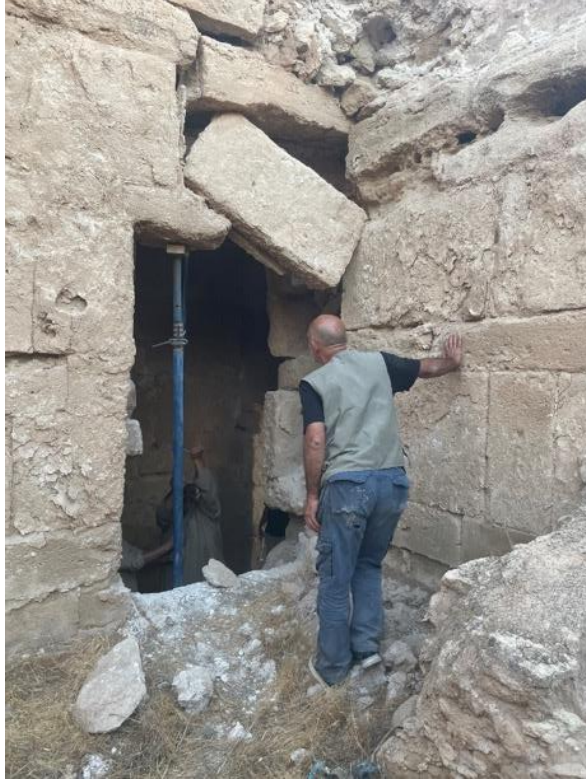
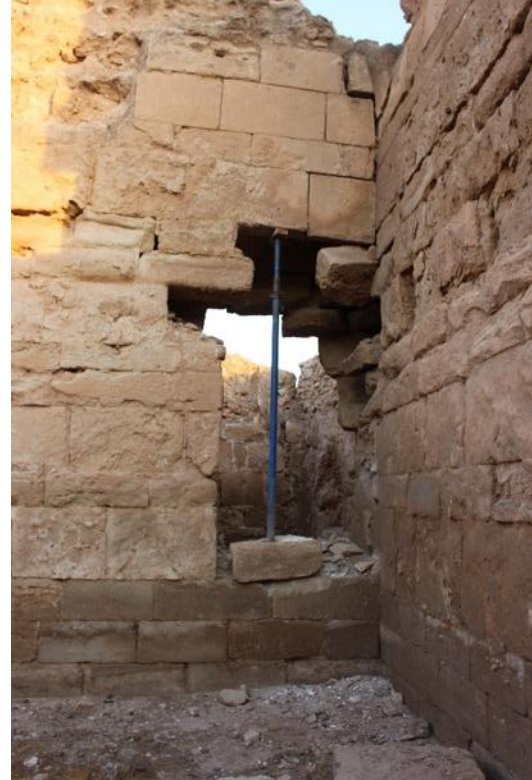
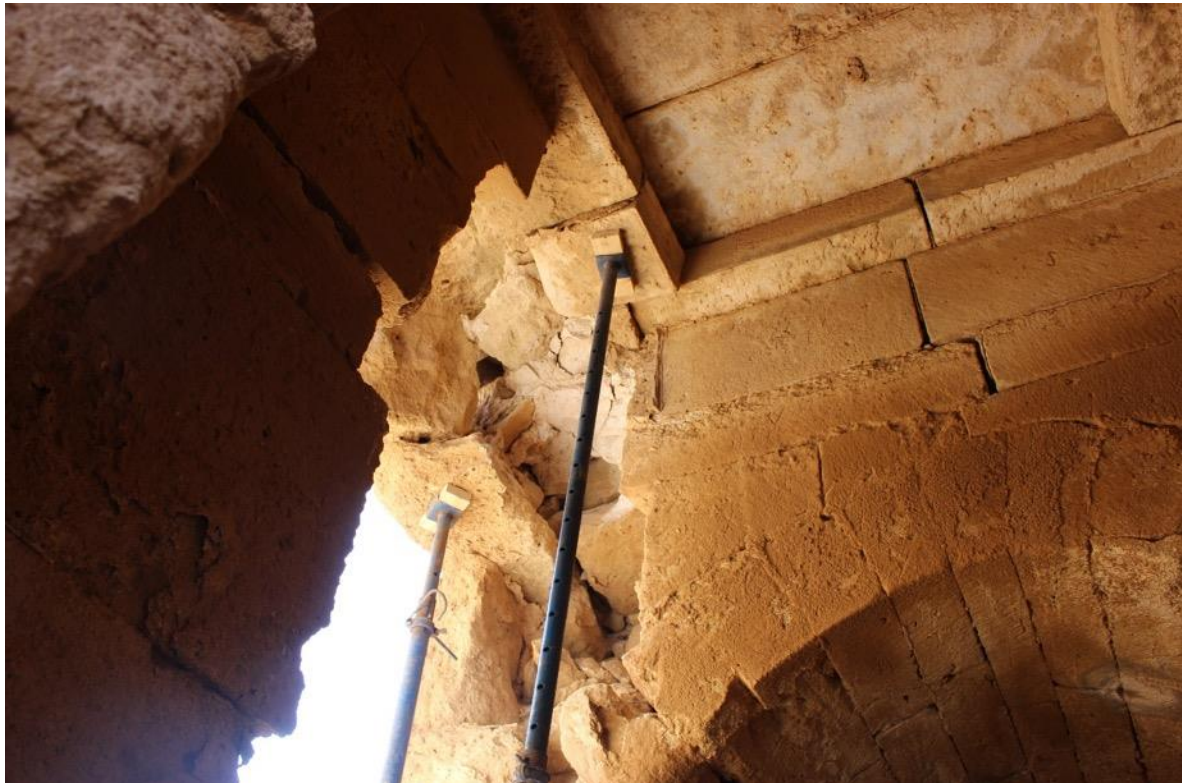
Fig. 64- 66: Shoring of the unsafe lintels.

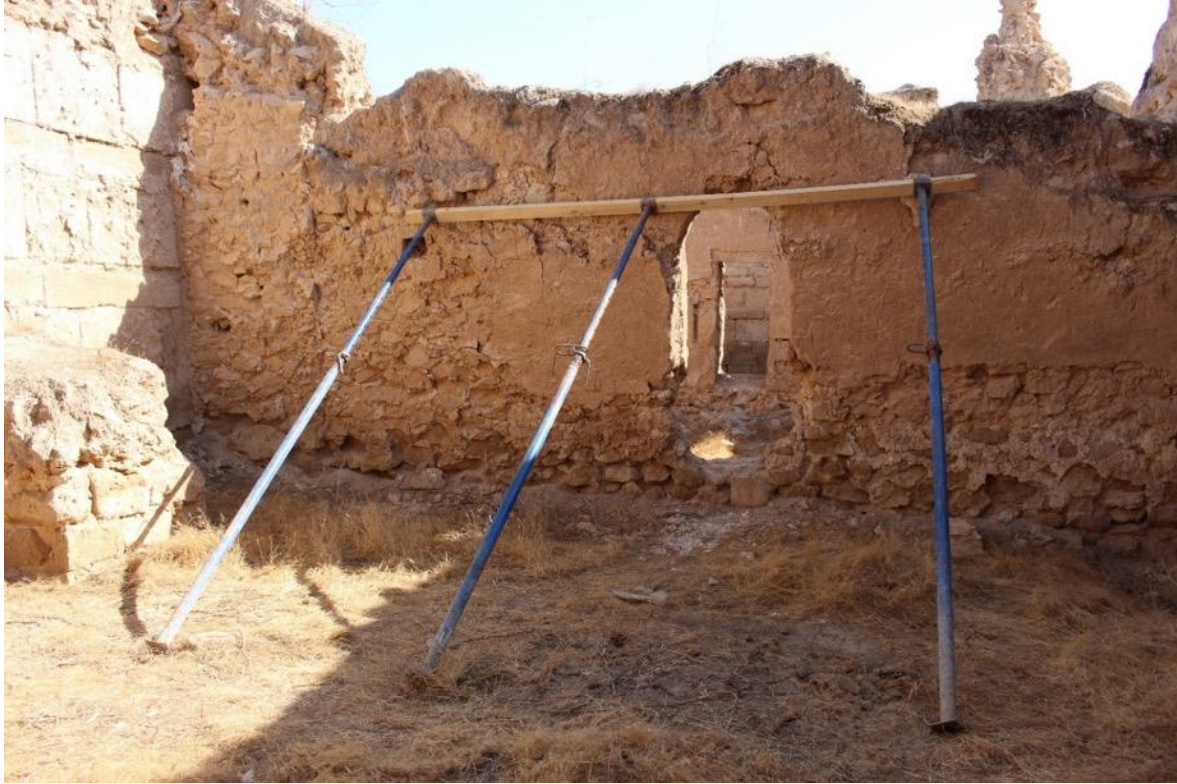
A later wall (most probably built in Zengid times), dangerously inclined, has been temporarily supported by scaffolding pipes and a wooden plank. The masonry and building techniques are evidently different and more irregular than those of the original hatrean architecture:

Fig. 67: The later wall supported by scaffolding pipes.
